# *the* Conduit

Summer 2008

## Recovery Boiler Lower Furnace Problems

**By Ronald Lansing, P.E.  
and Max Moskal**

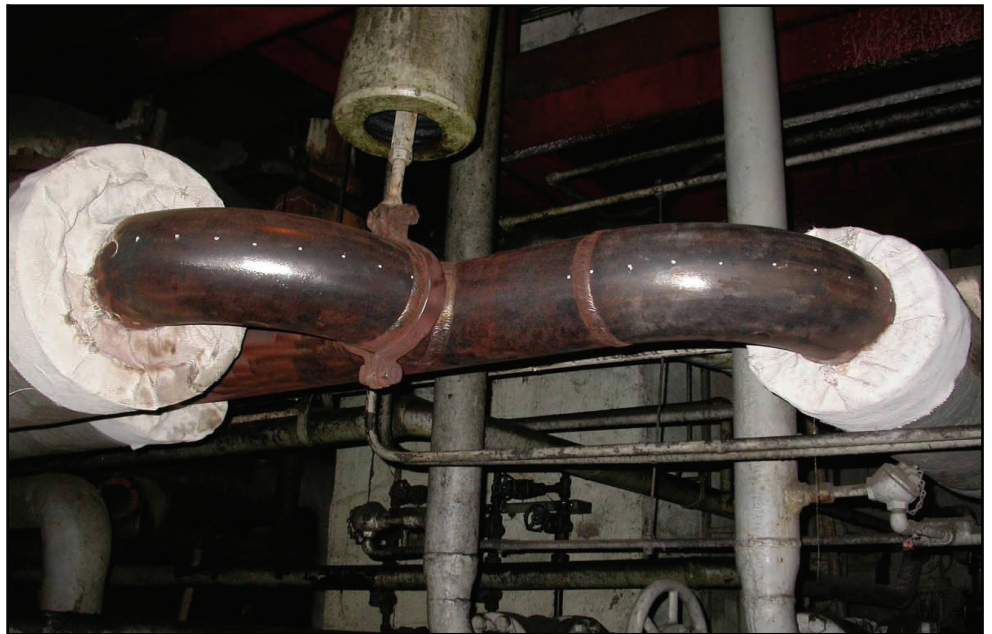
Surprisingly, evaluation of the boiler feedwater piping determined that very little thinning had occurred during the past fifty years of operation. Localized thinning down to 67% of the nominal thickness was measured on one elbow. On average, boiler feedwater piping thicknesses were near the nominal thickness. Since little thinning had occurred, it was recommended that future inspections of the boiler
